THE OVERCHARGE BEHAVIOR OF POLYMER  
ELECTROLYTE CELLS

R. Gopaliengar  
M.Z.A. Munshi  
B.B. Owens

Department of Chemical Engineering and Materials Science  
Corrosion Research Center  
University of Minnesota  
221 Church Street, SE  
Minneapolis, MN 55455  
USA

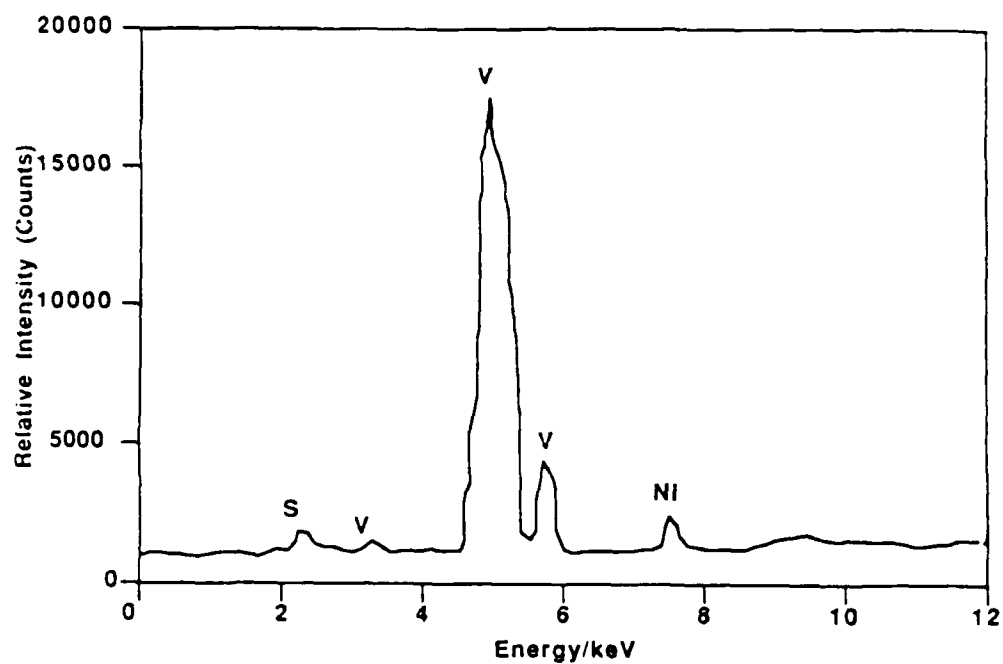
An EDAX analysis of the cathode cross-section indicated the presence of V, S and Ni (Figure 6). In addition, an analysis of the electrolyte cross-section near the lithium electrode interface showed the presence of S, Cl, V and Ni (Figure 7). The Cl appears to originate from impurities in the PEO. It is difficult to visualize the further oxidation of  $V_6O_{13}$  since it is already in a highly oxidized state. It is more likely that the presence of vanadium in the electrolyte is caused by physical migration of the vanadium oxide particles. At 100°C, the electrolyte is already a semi-fluid and during overcharge a considerable amount of heat is developed which would result in the lowering of the viscosity of the electrolyte. This would probably be sufficient to allow such particle migration.

Figure 6. EDAX analysis of the cathode cross-section (cell #1).

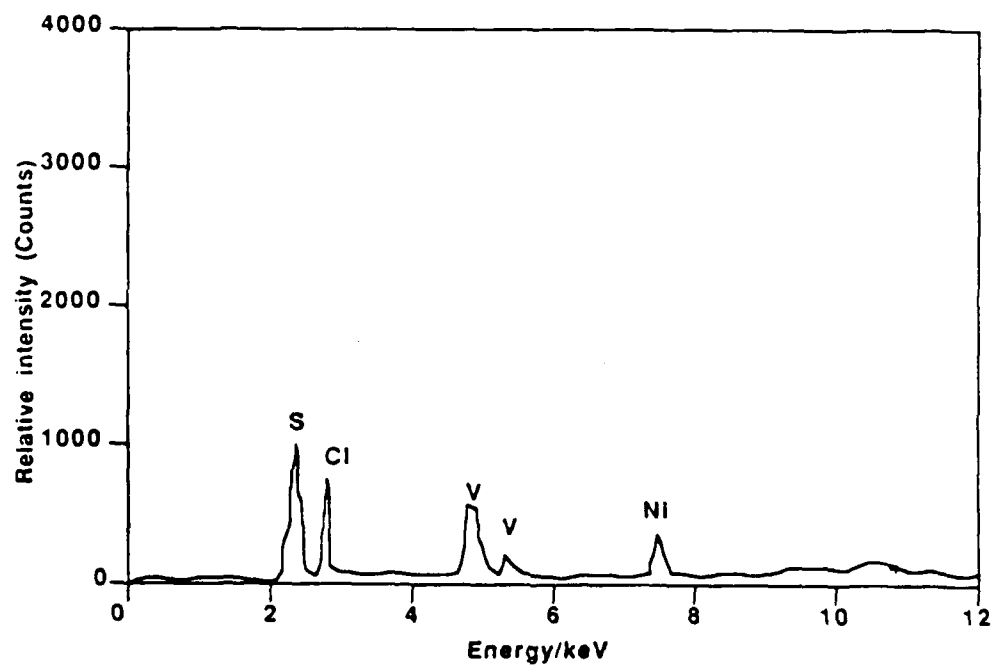
Figure 7. EDAX analysis of the electrolyte cross-section (cell #1).
